HVAC Systems Hygiene Assessment of the Sandels Building

**Sandels Building
Located at
675 West Call Street
Tallahassee, FL 32304**

HC3 Project #PJ220005

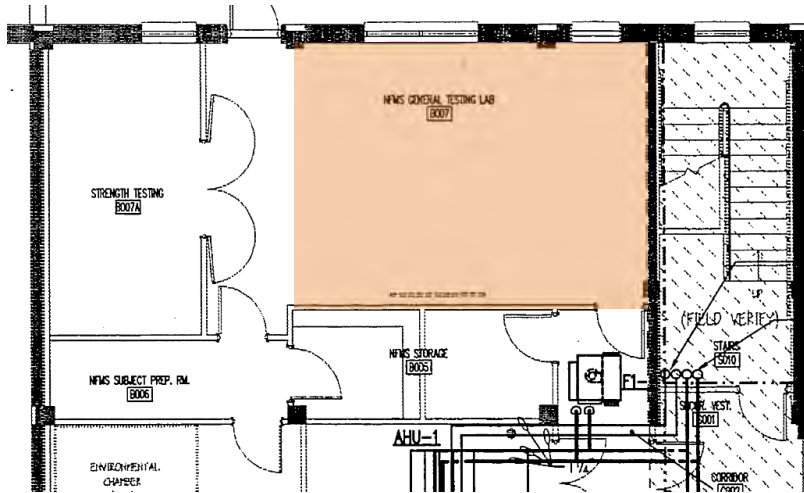
Figure 1: Basement

4.3.1 Basement Exercise Room Mats: Below the exercise mats in the basement along the South-facing wall mold growth was found. Vegetative structures of *Aspergillus/Penicillium*-like mold was found between the concrete floor and the mats, covering an area of approximately 20' x 24' (~480 square feet). The shaded area in the figure below represents the location of mold-impacted exercise mats. The mats act as a vapor barrier and trap moisture between the concrete and mat. Sample results indicate moderate spore production, but substantial vegetative growth. While in place there appears to be low risk of exposure to airborne spores from this area of growth, but odors and microbial volatile organic compounds (mVOCs) may be perceptible to occupants.

- 6.7 Remove and dispose of all gym floor mats in the basement. Clean the underlying flooring of all mold growth and residual mold growth deposits prior to application of a sealant or reinstallation of new mats. Assess moisture intrusion rates through the basement floor slab to determine an appropriate moisture vapor barrier product to prevent mold growth in the future.

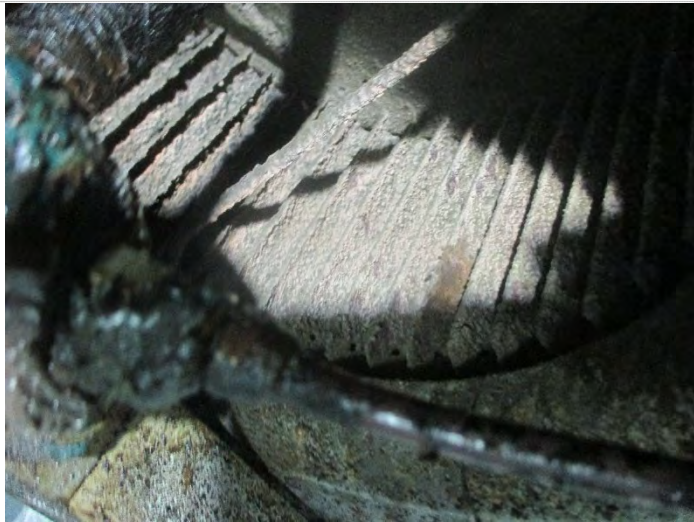
Photo 1: Sample # 1-2: AHU-1 Fan blade, far side
MSFV= 5179; over greased bearings with heavy debris

- 6.4 Clean, repair, or replace the fan bearings to prevent ongoing extrusion of grease into the AHU. Alter maintenance practices to avoid over greasing of fan bearings.

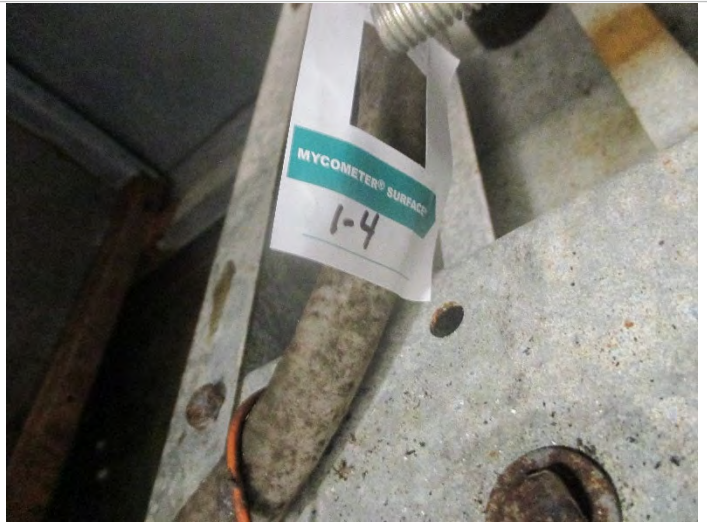
Photo 2: Sample # 1-4: AHU-1 Power line to blow motor,
MSFV= 7903; Category IV Aspergillus/Penicillium on
plastic coating of electrical cable inside AHU

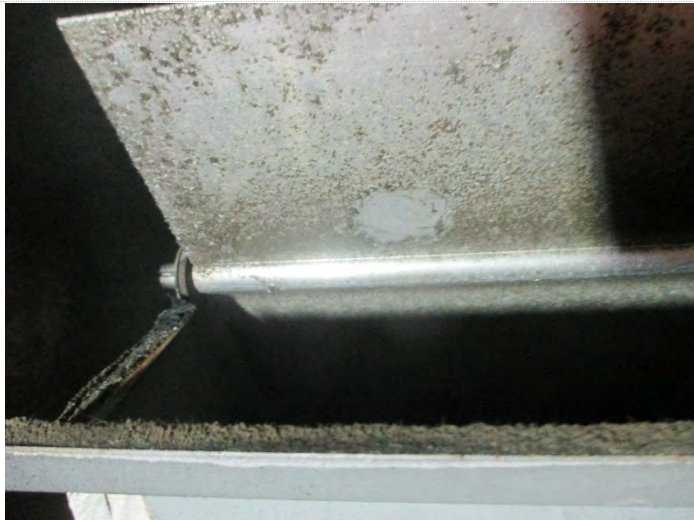
Photo 3: Sample # 1-5: VAV F1-1 Damper
MSFV= 4312, Heavy debris, located in hallway floor near
Rm B008

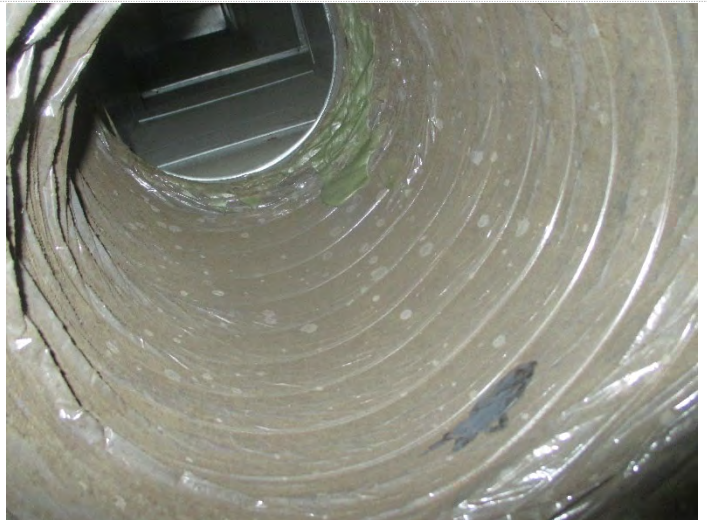
Photo 4: Sample # 1-8: VAV F1-1 HP Flex supply duct
MSFV= 2086, Located in hallway floor near Rm B008

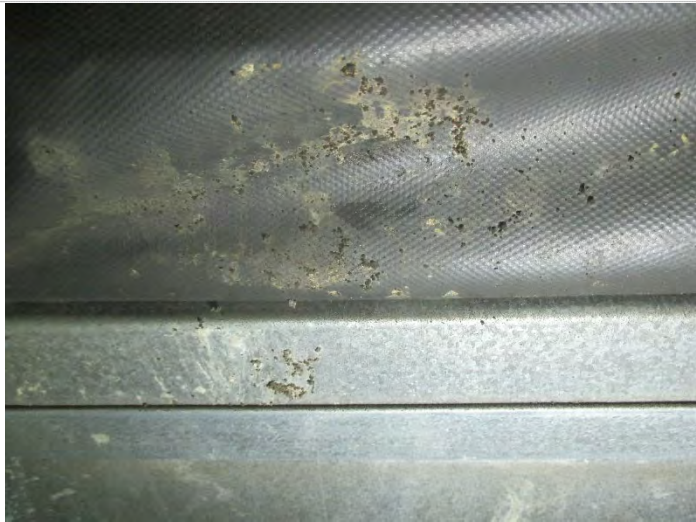
Photo 5: Sample # 1-9: VAV F1-1 LP Isolation vibration material MSFV= 185, Located in hallway floor near Rm B008

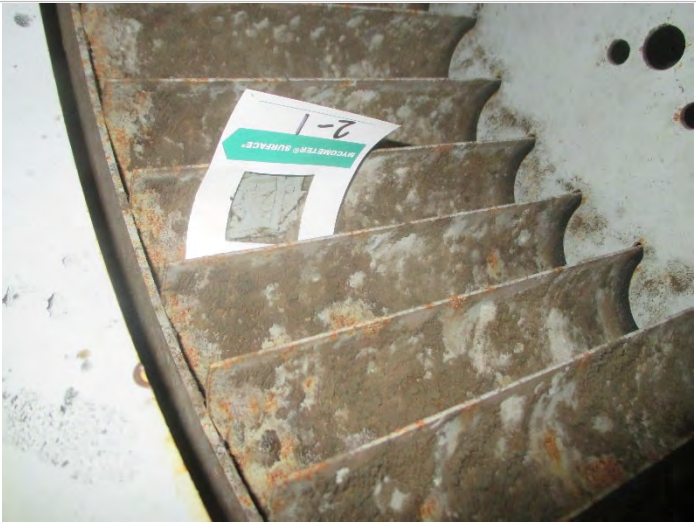
Photo 6: Sample # 2-1: AHU-2 Fan blade, far side MSFV= 7211

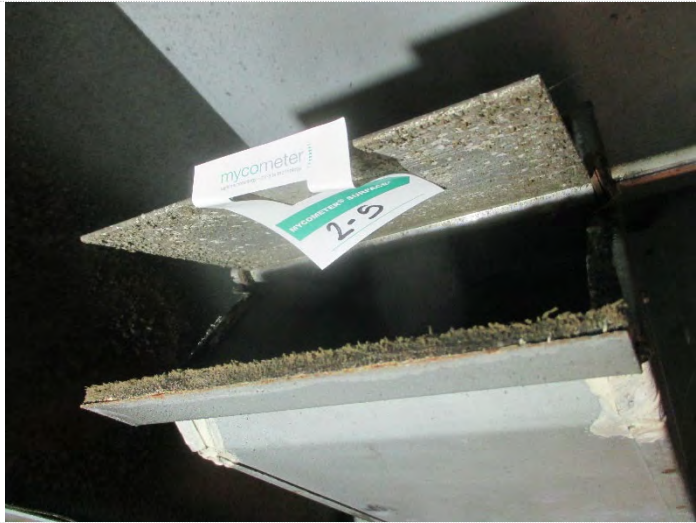
Photo 7: Sample # 2-5: VAV F2-2, Hallway damper, near Rm 108; MSFV= 6971

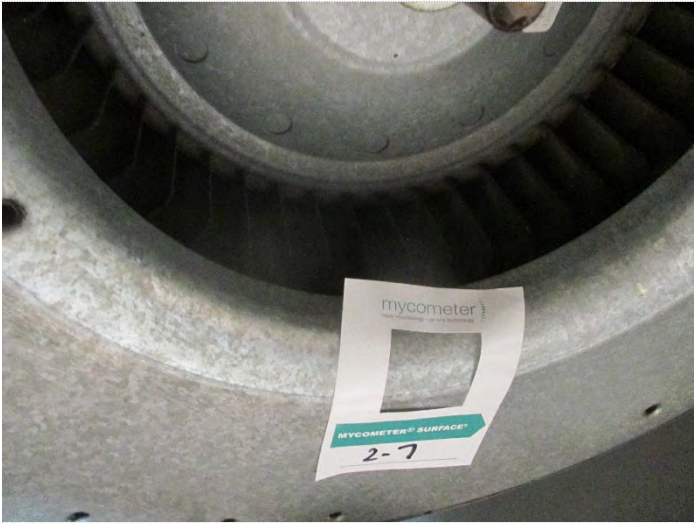
Photo 8: Sample # 2-7: VAV F2-2, Fan blade, near Rm 108; MSFV= 145

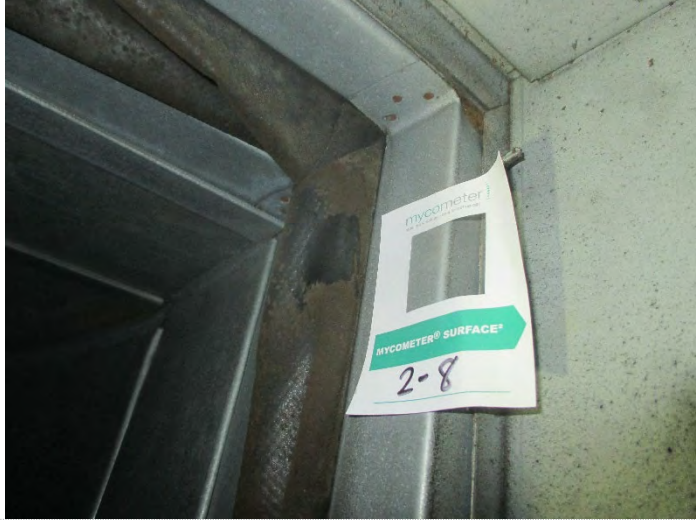
Photo 9: Sample # 2-8: VAV F2-2, LP Isolation vibration material, near Rm 108; MSFV= 28909

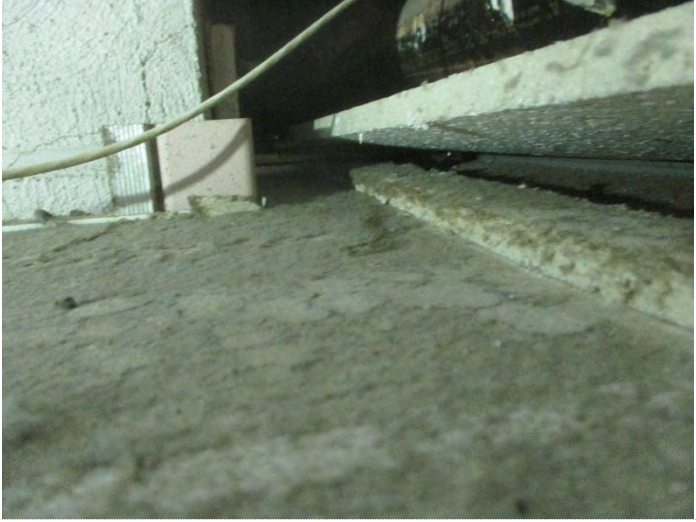
Photo 10: Sample # 2-10: Dust from the top of the ceiling tile near VAV F2-2; Category IV Mold growth of Penicillium/Aspergillus and Cladosporium Growth in Dust Deposits

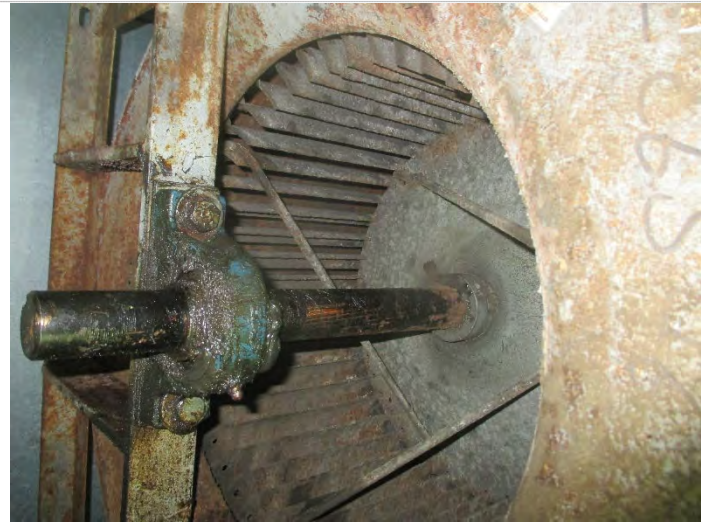
Photo 11: Sample # 3-1: AHU-3 Fan blade, far side
MSFV= 2726, Heavy debris with evidence of over greased bearings

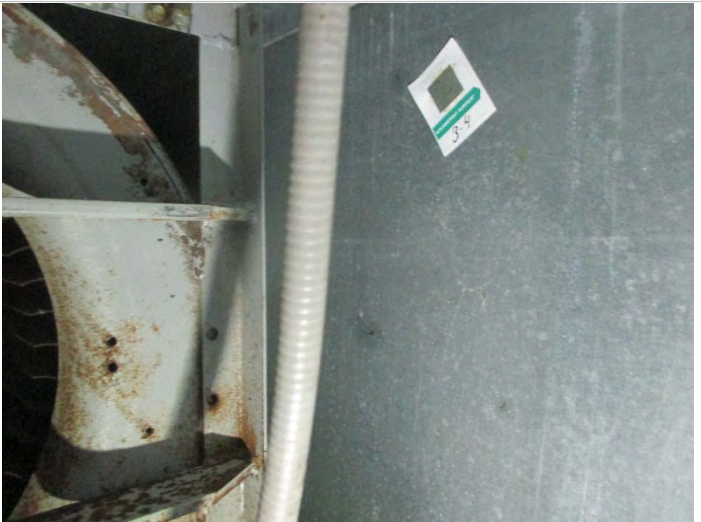
Photo 12: Sample # 3-4: AHU-3 Side panel with grease deposits, MSFV= 5

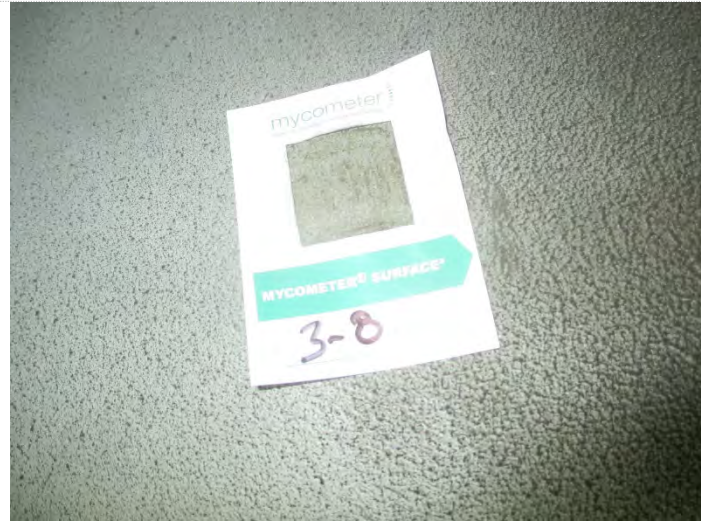
Photo 13: Sample # 3-8: VAV F3-3, Rm 108 Internal side;
MSFV= 59, Old inactive Mold Growth Category IV
Aspergillus/Penicillium and Chaetomium

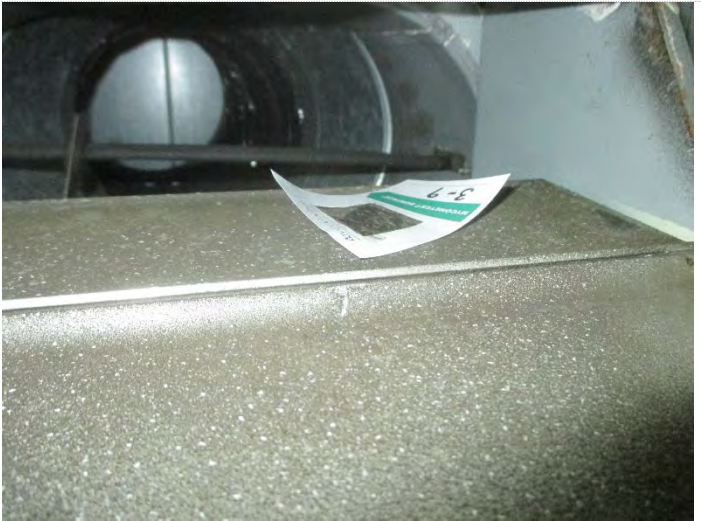
Photo 14: Sample # 3-9: VAV F3-3: Rm 108 Damper;
MSFV= 12037

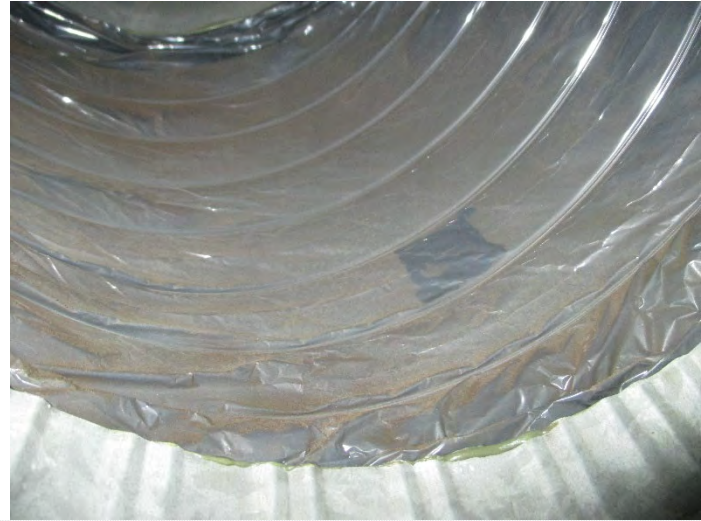
Photo 15: Sample # 3-10: VAV F3-3: Rm 108 Flex supply duct; MSFV= 6046

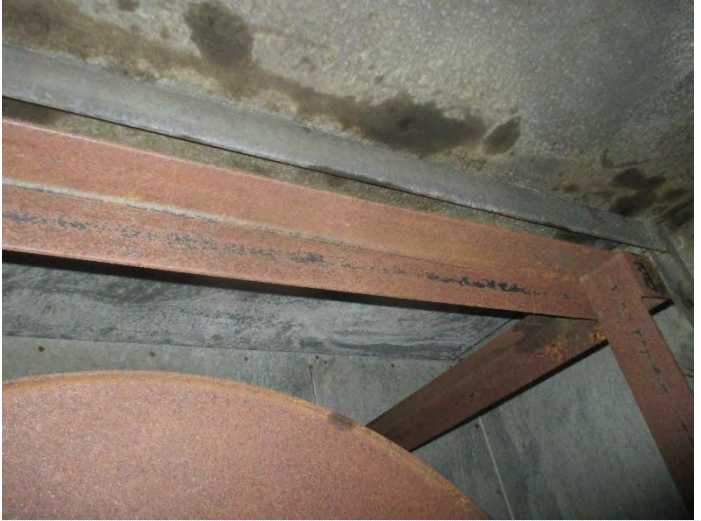
Photo 16: Sample # 4-1: AHU-4 Supply chamber outlet, top wall; MSFV= 322, (2nd floor) Above blower wheel

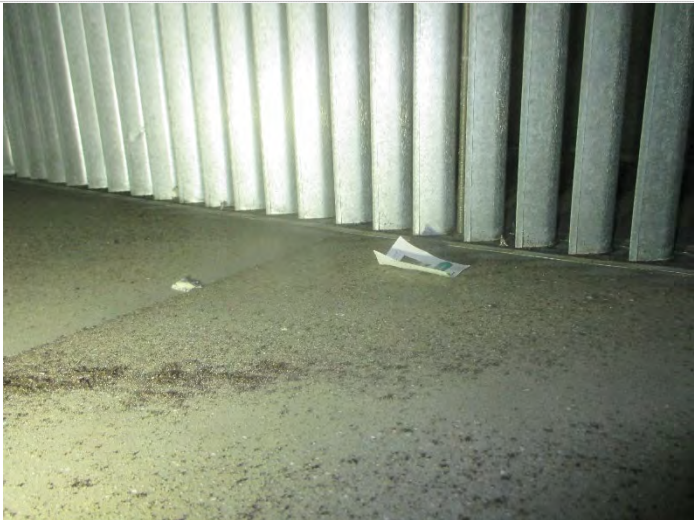
Photo 17: Sample # 4-2: Main supply trunk, access hatch near mechanical room entrance, MSFV= 797, Deposited mold growth shed from fan; Category III Cladosporium and Pen/Asp

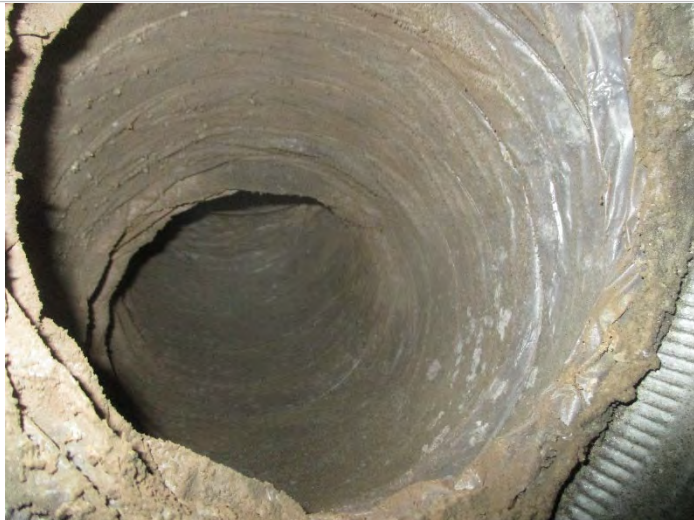
Photo 18: Sample # 4-3: Mechanical room flex duct from main supply trunk, MSFV= 10519

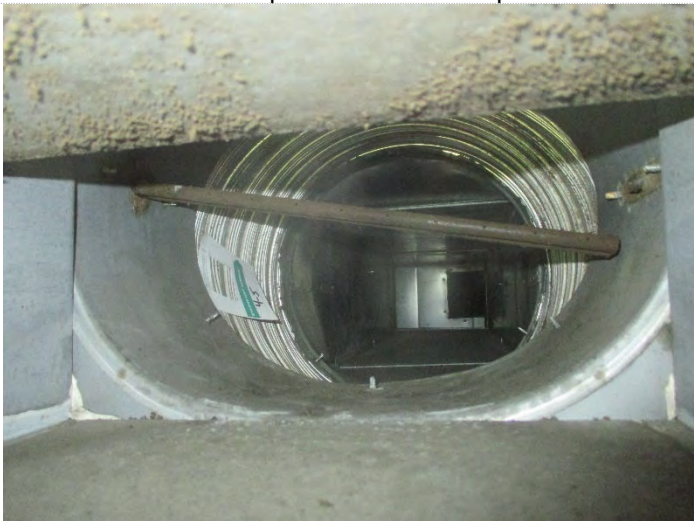
Photo 19: Sample # 4-5: VAV 4-11, Rm 225B Flex thermo fin, upstream of HP; MSFV= 2312, Mold Growth Category IV Aspergillus/Penicillium on internal metal surface of Thermo fin flexible duct

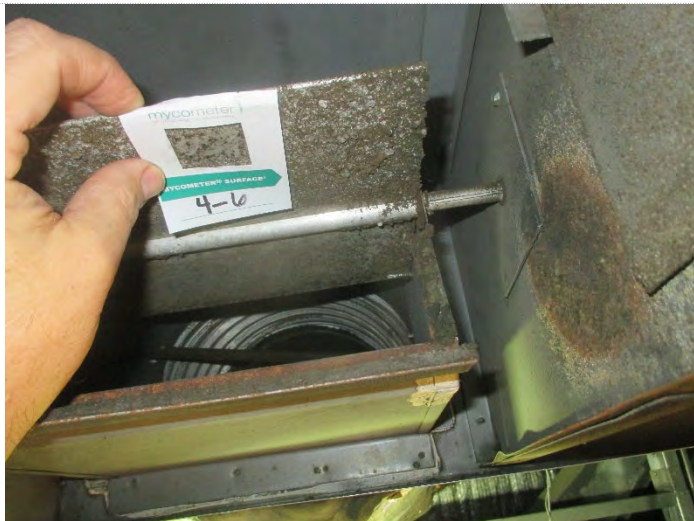
Photo 20: Sample # 4-6: VAV 4-11, Rm 225B Damper MSFV= 10944, Heavy debris and Mold Growth Category IV Cladosporium with moderate deposits of Aspergillus/Penicillium

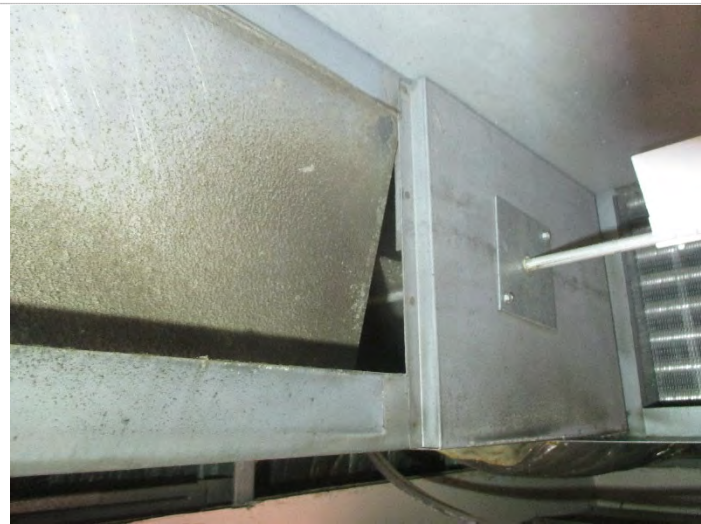
Photo 21: Sample # 4-7: VAV 4-11: Rm 225B Side panel; MSFV= 4862

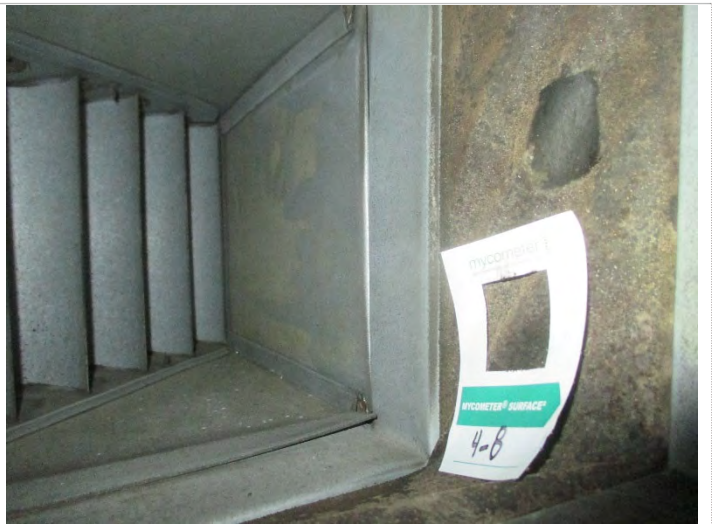
Photo 22: Sample # 4-8: VAV 4-11: Rm 225B Isolation vibration material, LP side; MSFV= 21403, Category II Aspergillus/Penicillium and Chaetomium

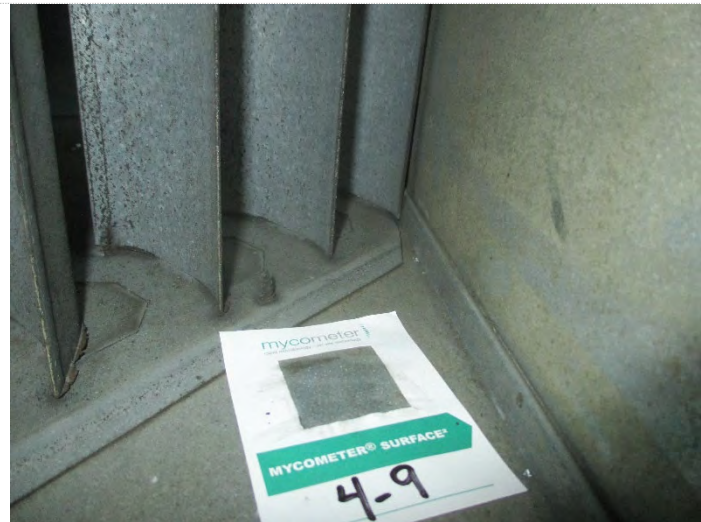
Photo 23: Sample # 4-9: VAV 4-11: Rm 225 Metal supply duct; MSFV= 145; Category II Aspergillus/Penicillium and Alternaria

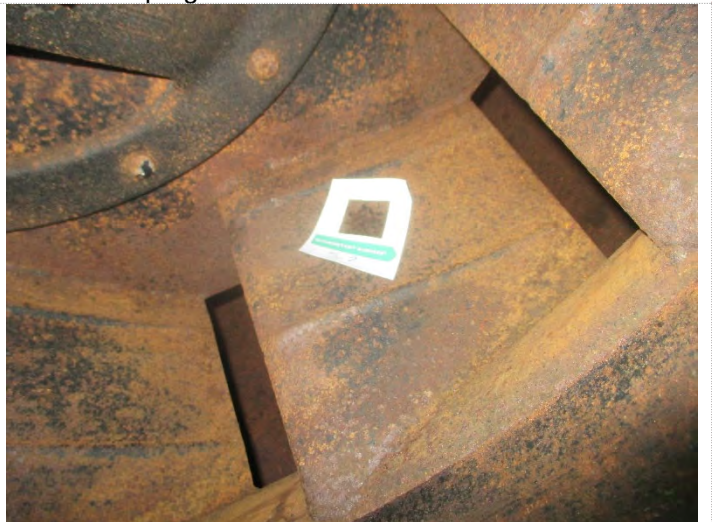
Photo 24: Sample # 5-2: AHU-5 Fan blade; MSFV= 265 Rust, grease stains

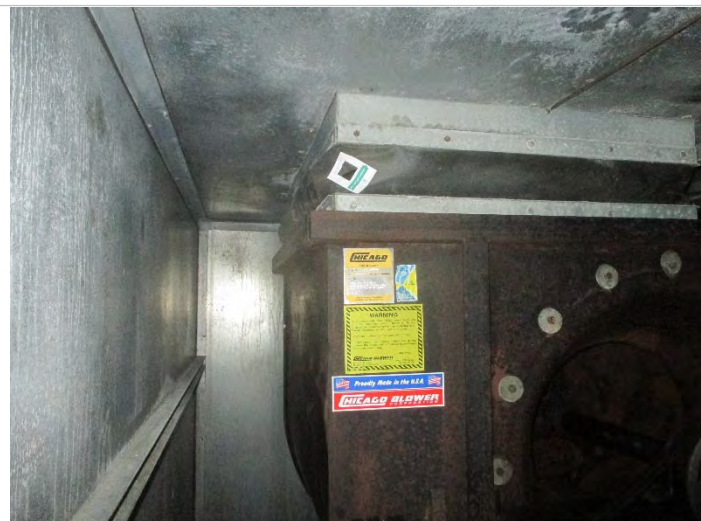
Photo 25: Sample # 5-3: AHU-5 Isolation vibration material, MSFV= 136, SMG

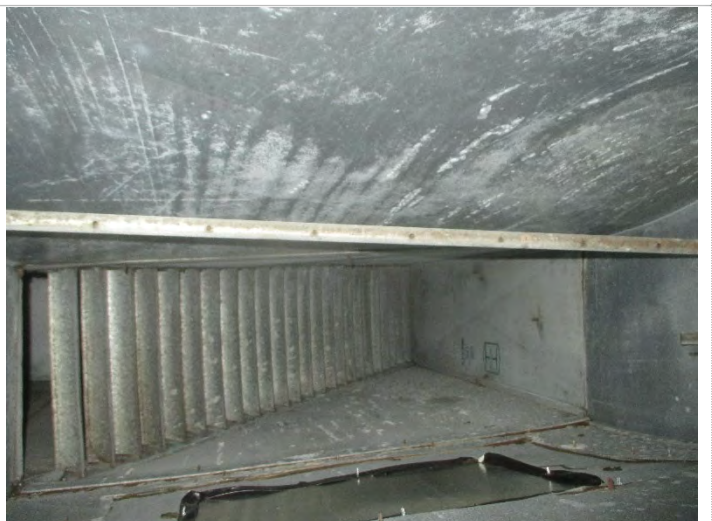
Photo 26: Sample # 5-4: AHU-5 Supply outlet turning vein, MSFV= 148, In Mech. Room

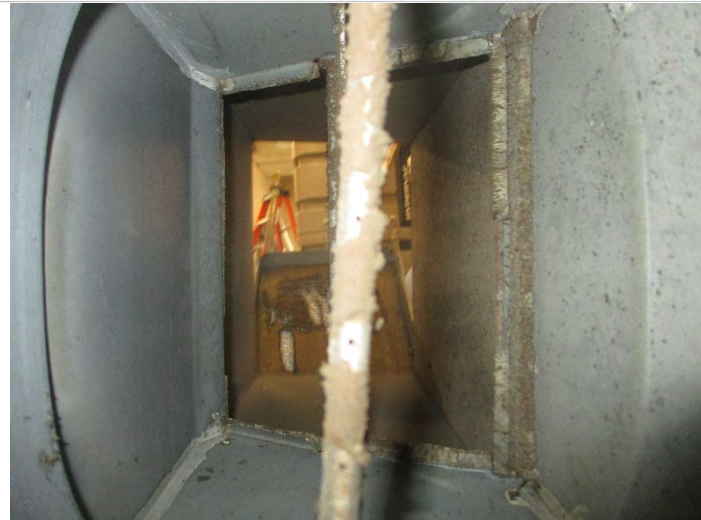
Photo 27: Sample # 5-5: Reheat unit, inlet side of heating coils, MSFV= 4384, Category IV Acremonium Mold Growth (Excessive debris on coils of re-heat) before cleaning

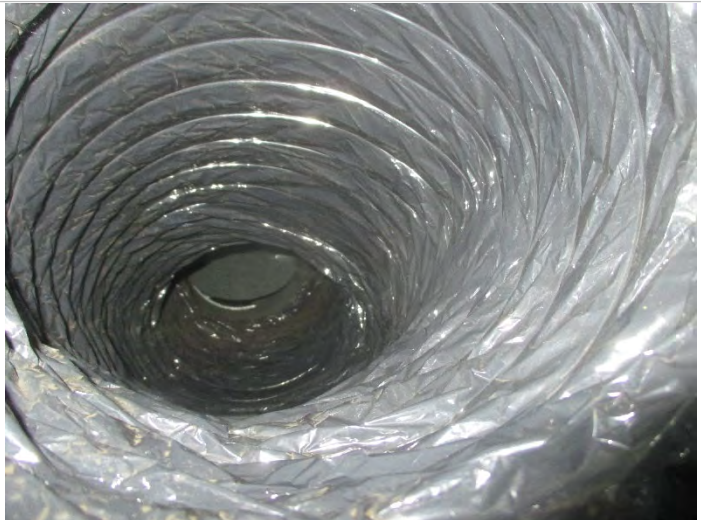
Photo 28: Sample # 5-6: Rm 326 Supply flex duct MSFV= 898, "Cleared"

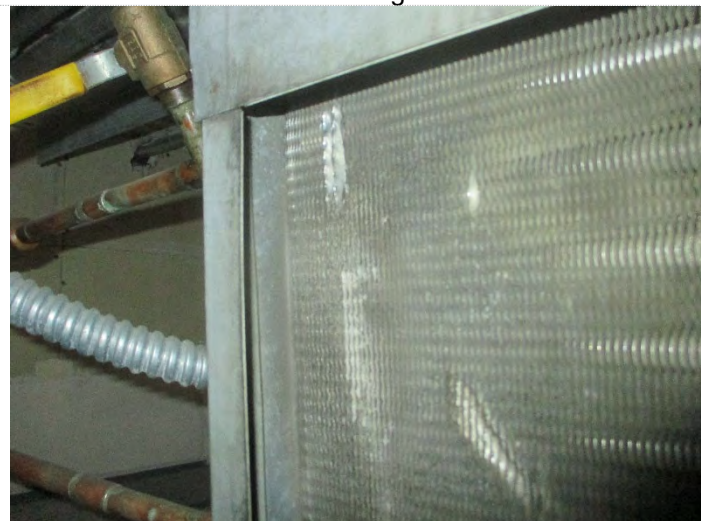
Photo 29: Sample # 5-8 Rm 318 VAV Cooling unit, inlet MSFV= 33, Dirty, had to bend filter to move it

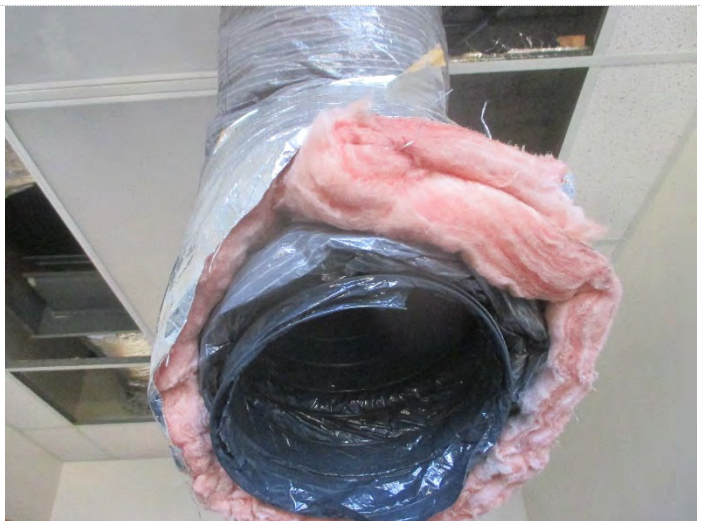
Photo 30: Sample # 5-11 Rm 316 Flex supply duct outlet MSFV= 184

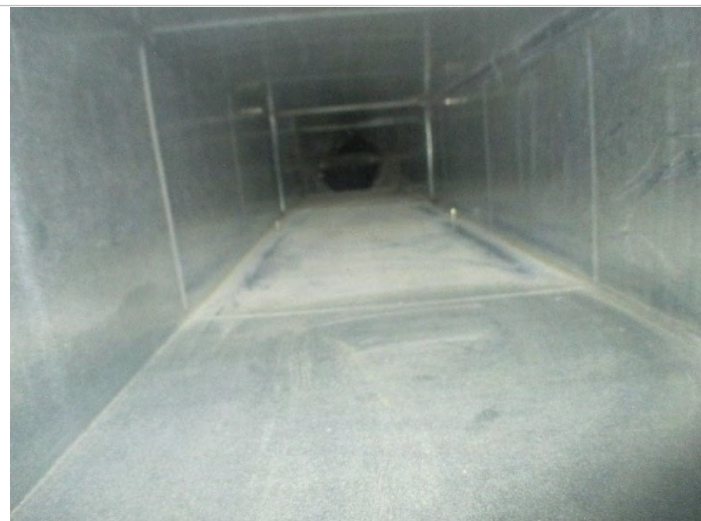
Photo 31: Sample # 5-14 Rm 332C LP Metal supply duct MSFV=45

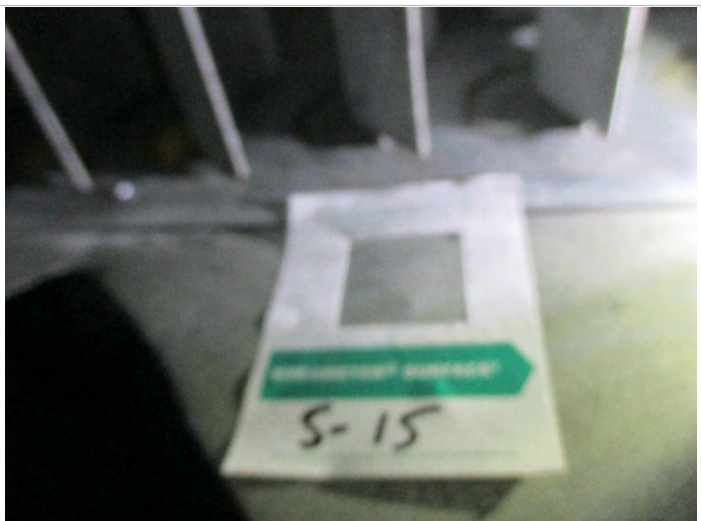
Photo 32: Sample # 5-15 Corner hallway base of HP supply duct, near turning vein; MSFV=30, Near stairway stairs

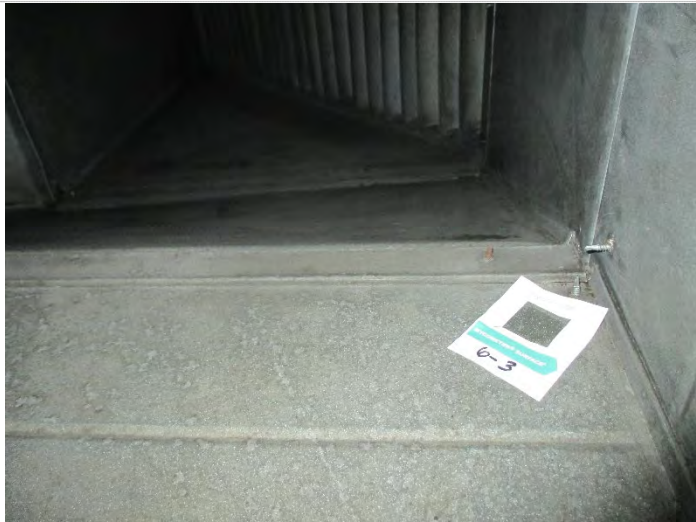
Photo 33: Sample # 6-3: AHU-6 HP supply duct plenum; MSFV= 16

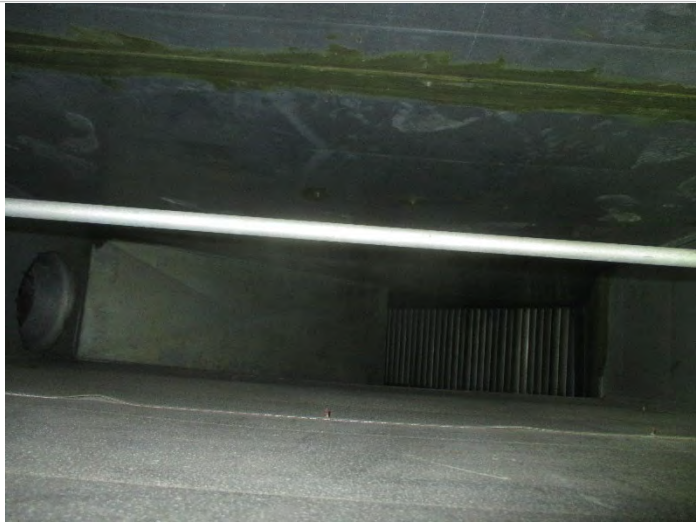
Photo 34: Sample # 6-4: AHU-6 Main metal supply duct to hallway; MSFV= 40

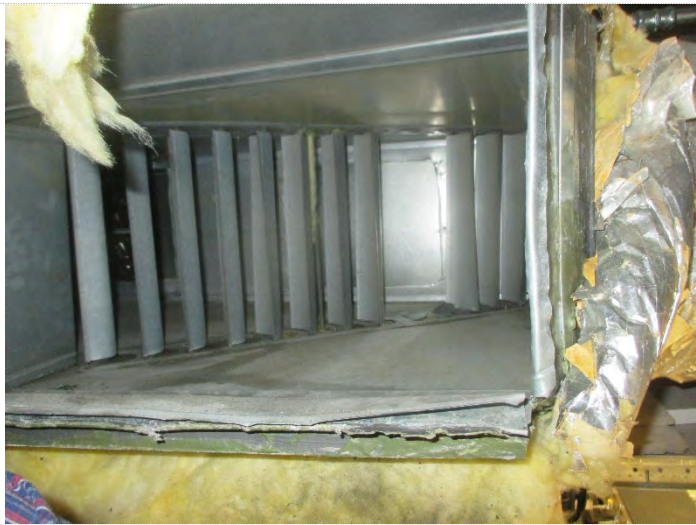
Photo 35: Sample # 6-6: Reheat Unit C6-6 LP Metal Supply Duct pass Rm 440 VAV; MSFV= 35, Category IV Old, inactive mold growth Cladosporium

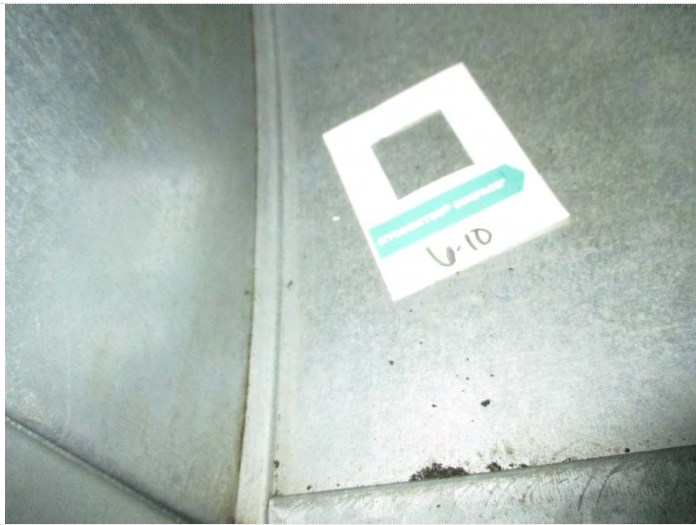
Photo 36: Sample # 6-10: Rm 442E LP Metal supply duct MSFV= 40

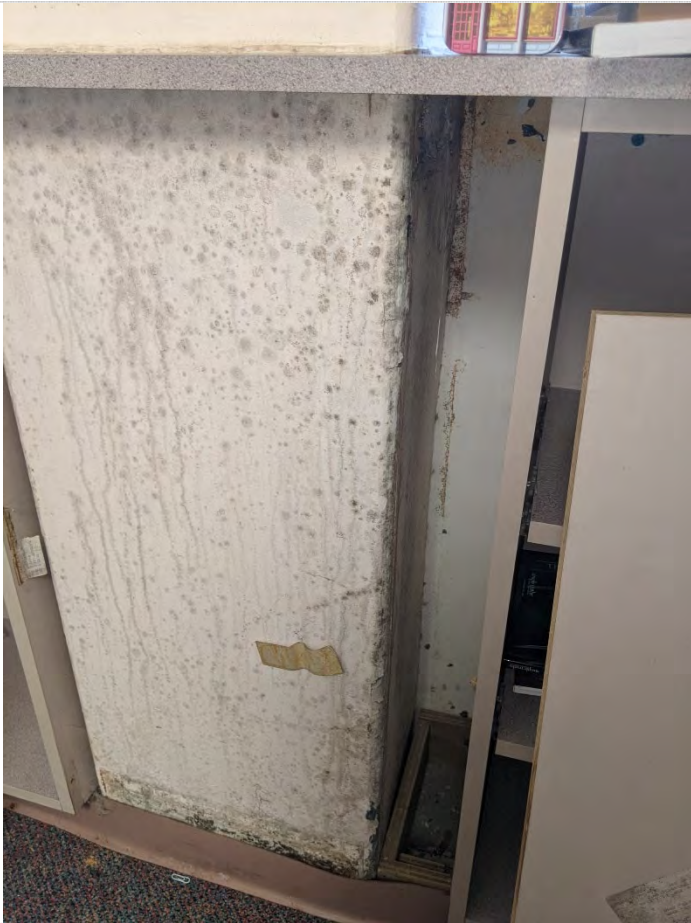
Photo 37: Sample # 220-1: Room 220 Column built-in bookshelf, front; Category II Low density mold growth of Aspergillus/Penicillium and Cladosporium

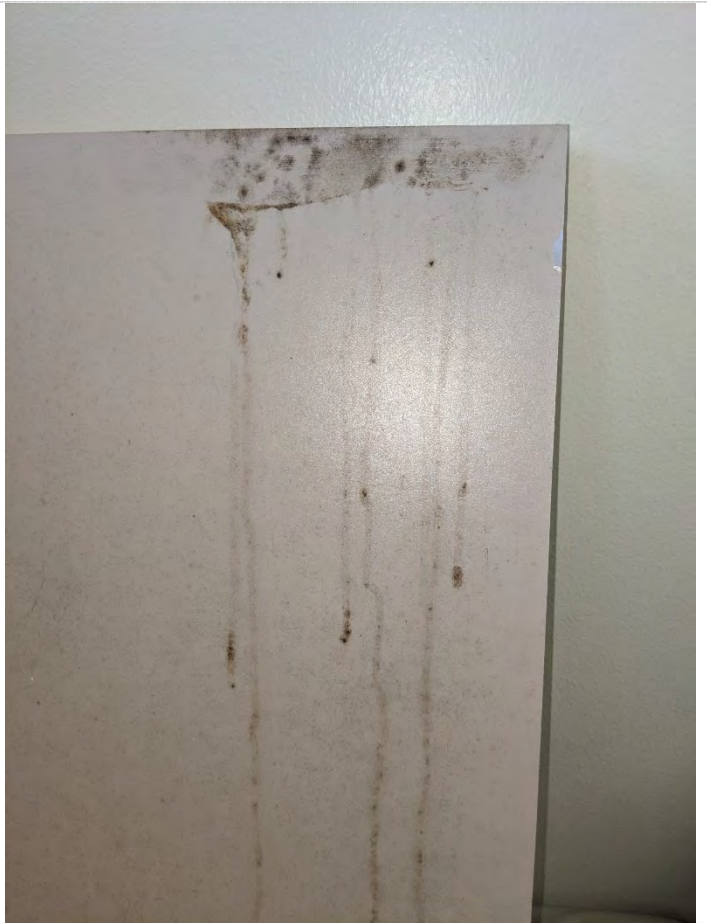
Photo 38: Sample # 328-3: Room 328 Built-in Bookshelf, Back Cover Category IV Mold Growth of Cladosporium

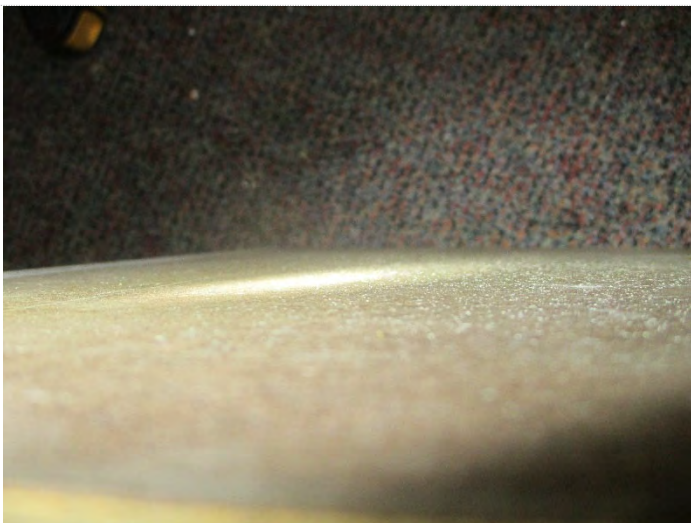
Photo 39: Sample # 420-3: Room 420 Built-in bookshelf, Underside (bottom); Category IV Mold Growth of Aspergillus and Penicillium

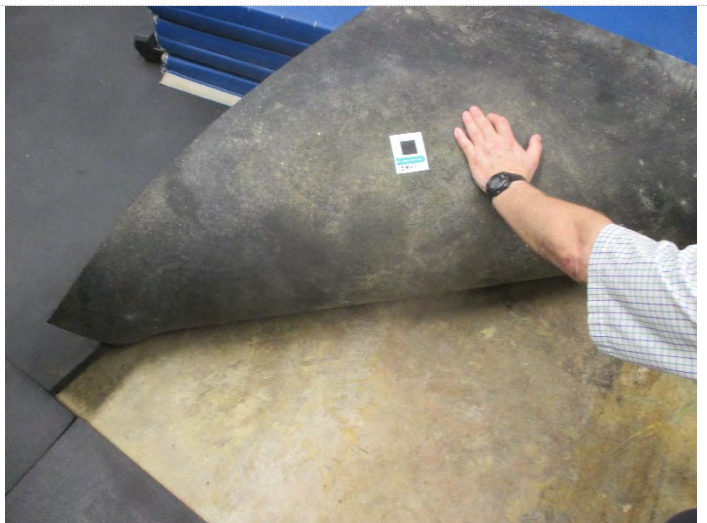
Photo 40: Sample # GM-1: Gym floor mat backside surface, Mat #4 from left MSFV= 6077 Category II Vegetative mold growth (Asp/Pen-like) due to moisture through slab or water damage from flooding reported, Mat # 4 from left- facing emergency exit door

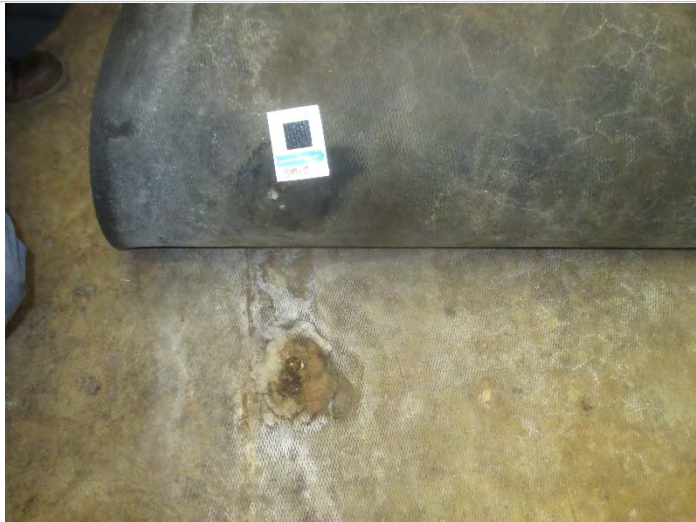
Photo 41: Sample # GM-2: Gym floor mat backside surface, Mat 14 from left MSFV= 7731
Category II Vegetative mold growth (Asp/Pen-like) due to moisture through slab or water damage from flooding reported, Mat # 1 from left-facing emergency exit door

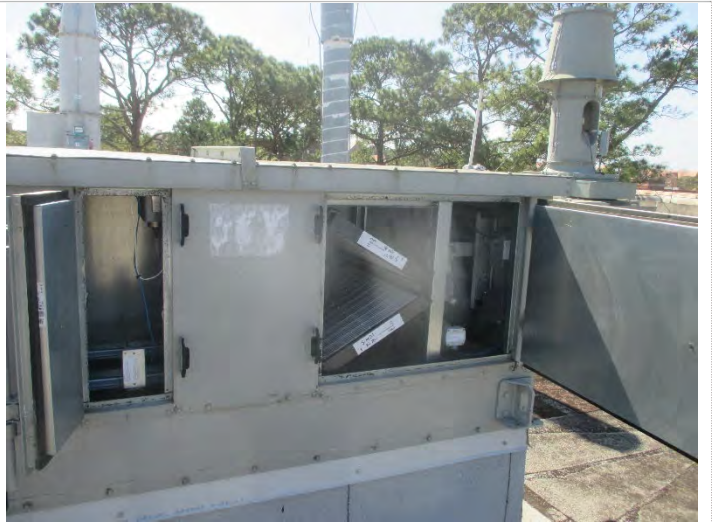
Photo 42: Sample # RT-1: Rooftop AHU cooling coils inlet MSFV= 0, Access from 411 Mech Rm

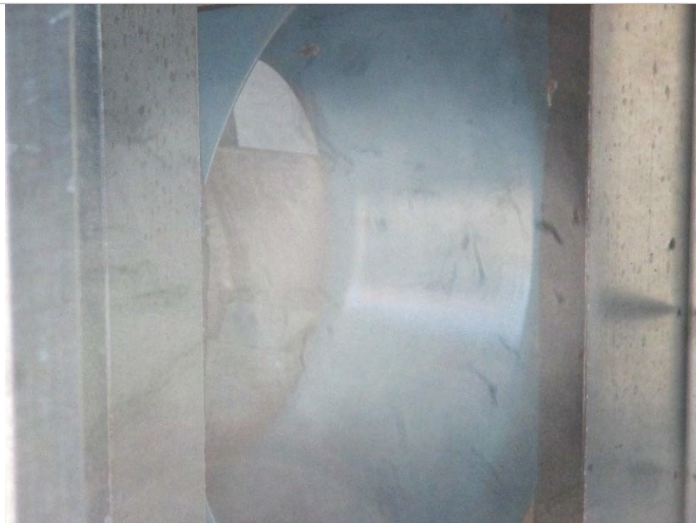
Photo 43: Sample # RT-2: Rooftop AHU Fan blade MSFV= 4, Access from 411 Mech Rm
